Guideline for Visual Inspection of Balconies

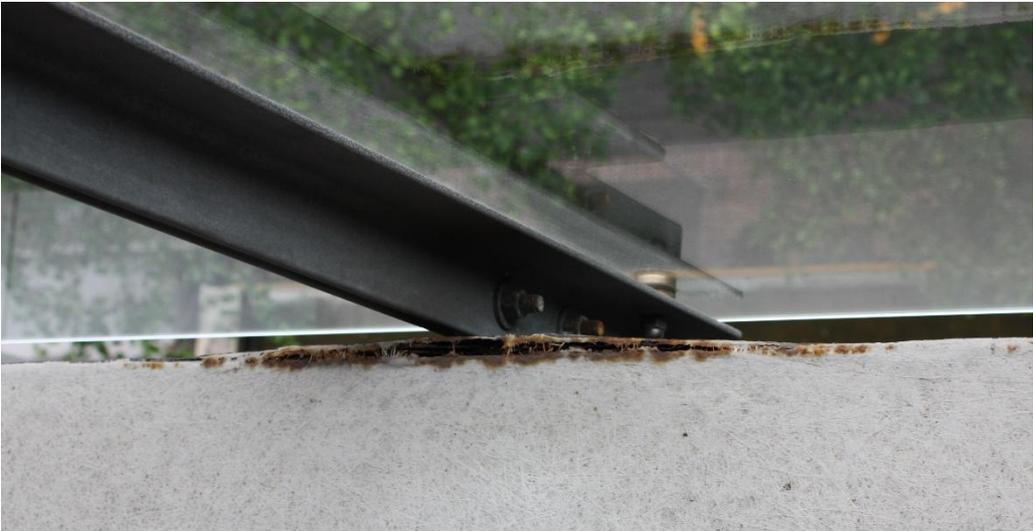
Step	Action
<p>What is the problem?</p>	<p>The protective material which covers the floor of the balcony and overlaps the front edge of the balcony has become detached on one balcony that we know of.</p> <p>Further balconies may suffer the same separation.</p> <p>This gradual deterioration can become a water catchment area which collects moisture and rust may start to form. This is particularly so as 54-66 Willis Street has a medium to high risk of windblown salt spray.</p> <p>If left to continue the deterioration could affect the integrity of elements of the building.</p> <p>The photo below illustrates the problem. Note: not all balconies have glass frontages so may look different to this.</p>

<p>Step Three Permanent Repair</p>	<p>The Owner should seek advice and consider options for repair, in consultation with the Facilities Manager if necessary.</p> <p>Should the separation of the linings be small, no water seepage detected or rust, then repairs can be made if appropriate materials are at hand.</p> <p>There may be a need for a waterproof membrane expert to provide advice and if so, the Owner will need to enlist this service, keeping the Body Corporate Facilities Manager informed as they proceed with this.</p> <p>Where the separation is more serious and resembles that which is reflected in the photo then a competent repair person will need to be employed.</p>
<p>Step Four Sign Off</p>	<p>Once completed photos and written detail of the repair from the repairer will need to be provided to the Body Corporate. This will be considered by the Management Committee and when they are satisfied, kept on file.</p>

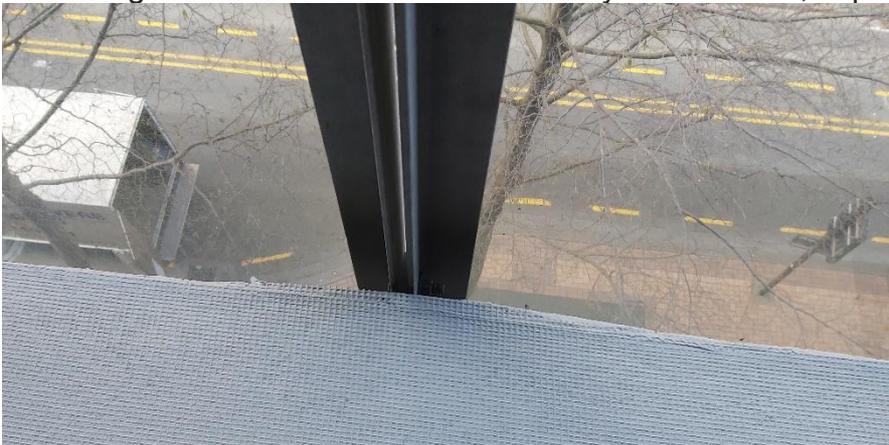
<p>Photo showing repaired balcony floor.</p>
